# **LITTLE SALMON CARMACKS FIRST NATION COMMUNITY WELL PROTECTION PLAN**

*Prepared For*  
**LITTLE SALMON CARMACKS FIRST NATION**  
Post Office Box 135  
Carmacks, YT  
Y0B 1C0

*By*  
**VISTA TEK LTD.**  
803 WOOD STREET  
WHITEHORSE, YT, Y1A 2G6

**Re: LSCFN Well Head Protection Plan**

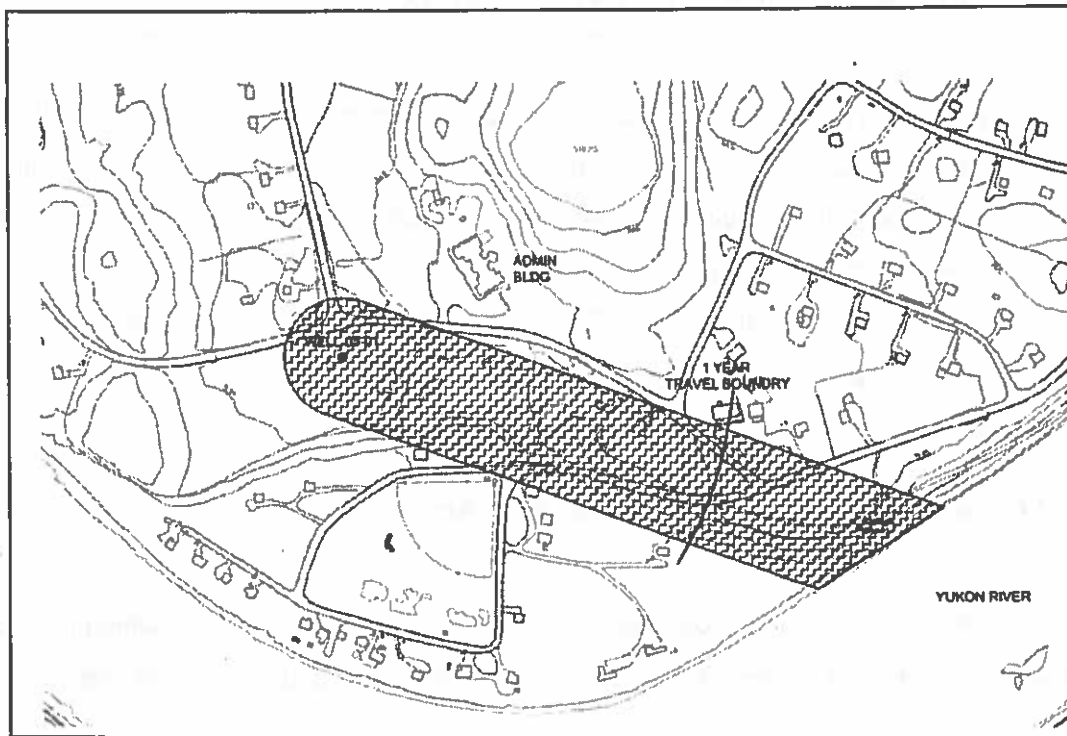
Figure 9 – Estimated Capture Zone and Travel Boundaries

The results of the capture zone analysis are summarized graphically in figure 9 that indicates a 120m wide capture path extending to the Yukon River. The majority of the capture zone is within the one year travel time boundary and the entire capture zone (including the Yukon River) should be considered as a high-risk area for management purposes.

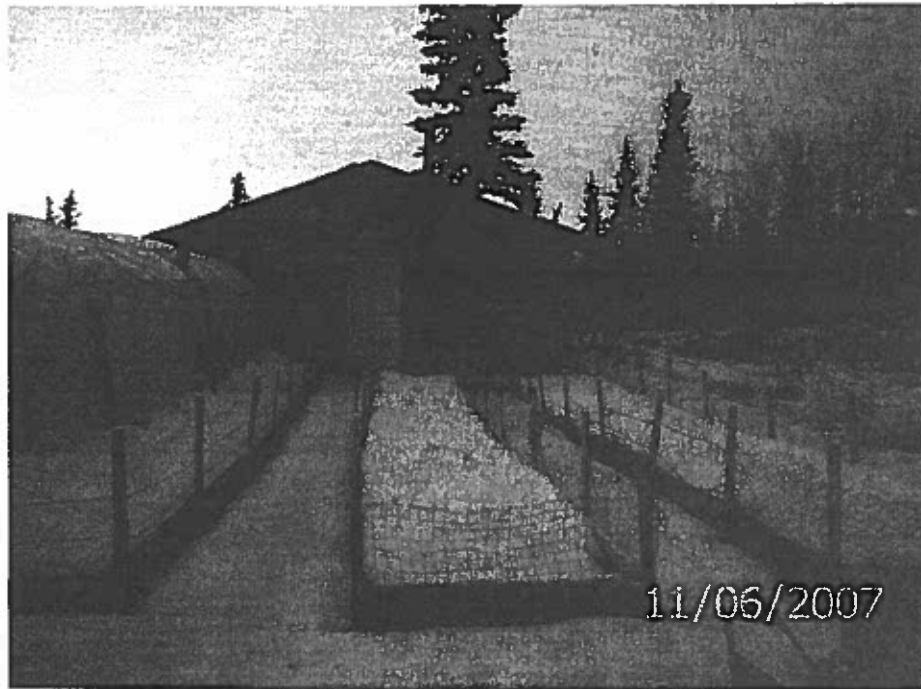
**Photo 1**  
**LSCFN Green House**

- Green House (GH)
  - There is a potential for nitrates/nitrites and pathogens to leach from manure stored at the site into aquifer
- UST (UST 1) at Old Laundromat
  - Although this underground storage tank is not currently in service, there is a potential for hydrocarbons from old spills or leaks to enter into aquifer

Green House	Off site storage of manure
UST	UST removal & replacement
Maintenance Shop	Complete inventory of potential contaminants on site; determination if special waste permit is required
Septic tanks/fields	Inspect tanks once per year to make sure they are working properly; regular pump-outs; education for home owners regarding proper maintenance of fields
Fuel oil spill at Health and Social Services Building	Continue follow-up sampling on water wells within vicinity of spill to ensure no hydrocarbon contamination is present; conduct follow-up soil sampling
<p><i>Signage-</i> signs delineating water source protection zone will be made and posted around zone to make public aware of the area, especially roads in the management area.</p> <p><i>Education-</i> pamphlets and community discussions will help spread awareness of the well head protection plan and the APEC's within the protection zone. Education on what activities are permitted within the protection area will be a focus for LSCFN staff.</p>

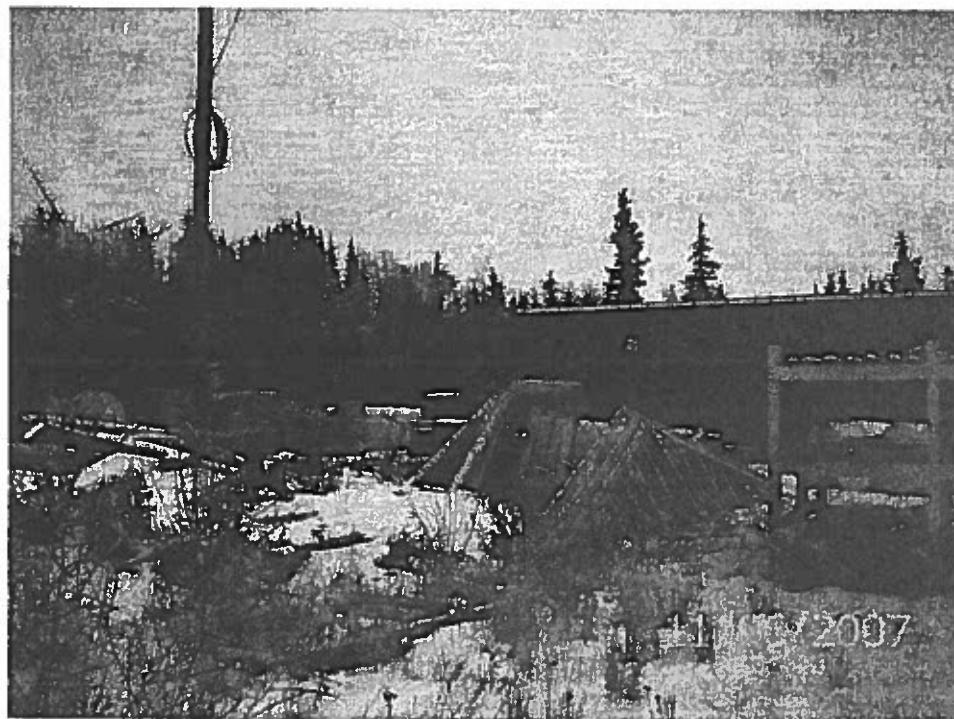
**Photo 2 Maintenance Shop**

- **Septic Field (SF)**
  - There is a potential for heavy metals, solvents, household waste products, fecal coliforms, etc., to enter into aquifer
- **Maintenance Shop (MS)**
  - There is a potential for hydrocarbons and other maintenance chemicals (anti-freeze, glycols, etc.) to enter into aquifer
- **UST (UST 2) at Heritage Hall**
  - Although this underground fuel oil storage tank is located outside the estimated capture zone, there is still concern that a large spill may affect the aquifer

The maintenance shop received a medium Hazard Consequence Criteria due to relatively low volume of petrochemical products stored on site.

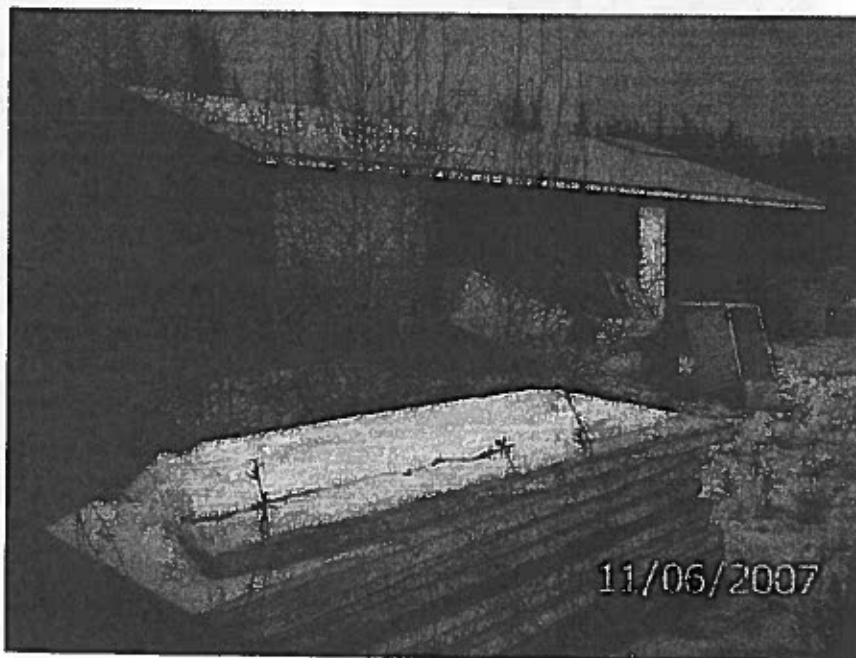
**Photo 5**  
**LSCFN Old Laundry Mat**

As the underground storage tank at the old Laundromat (UST 1) is located within the capture zone, its exposure likelihood is high. It also ranks high in the hazard consequence criteria, as any discharge from old spills or leaks could potentially affect ground water quality and have serious health effects on humans. This tank should be removed and the area remediated to reduce this risk.

- \* 3. Remove and replace existing UST at Heritage hall with approved AST and complete level II environmental assessment;
- \* 4. Remove existing UST at old community Laundromat and complete level II assessment;

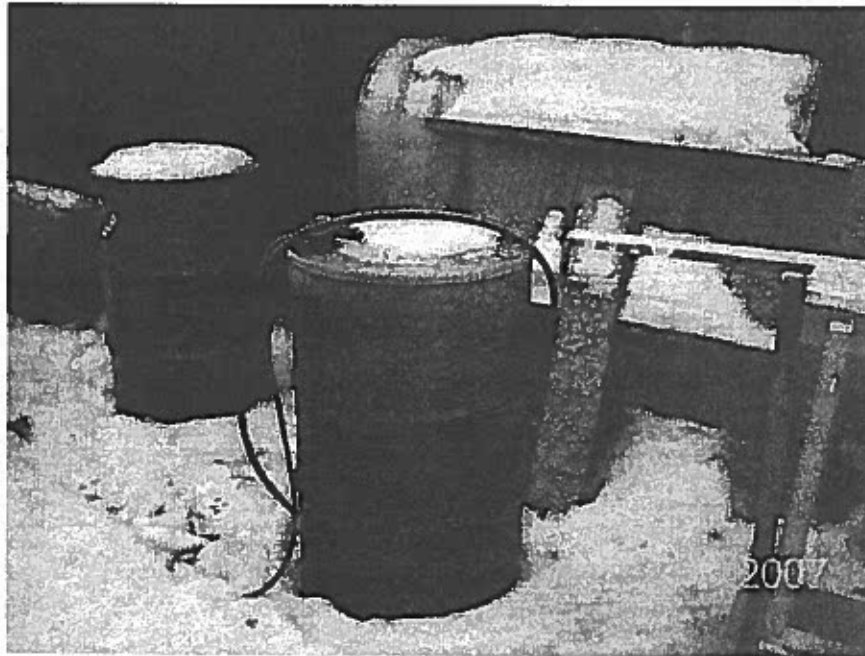
**Photo 7**  
**Fuel drums located on Maintenance Shop**

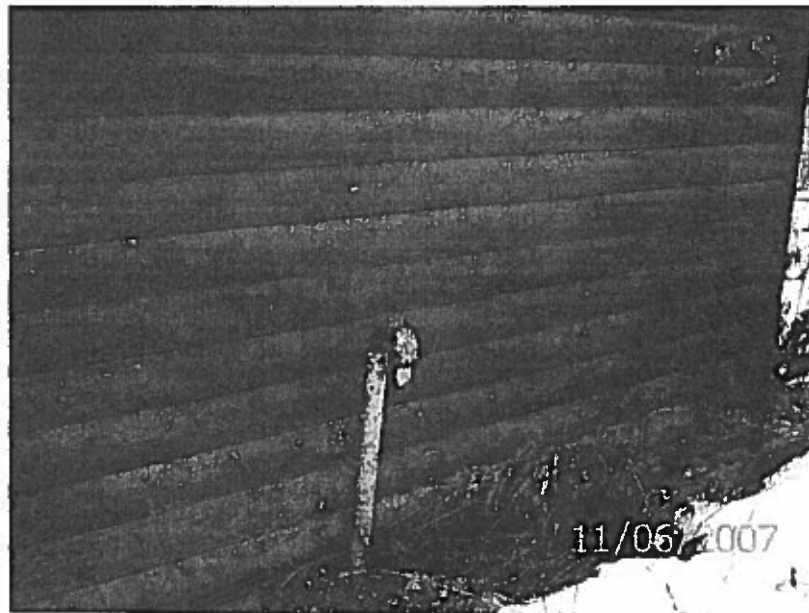
**Photo 8**  
**UST at Old Laundry Mat**

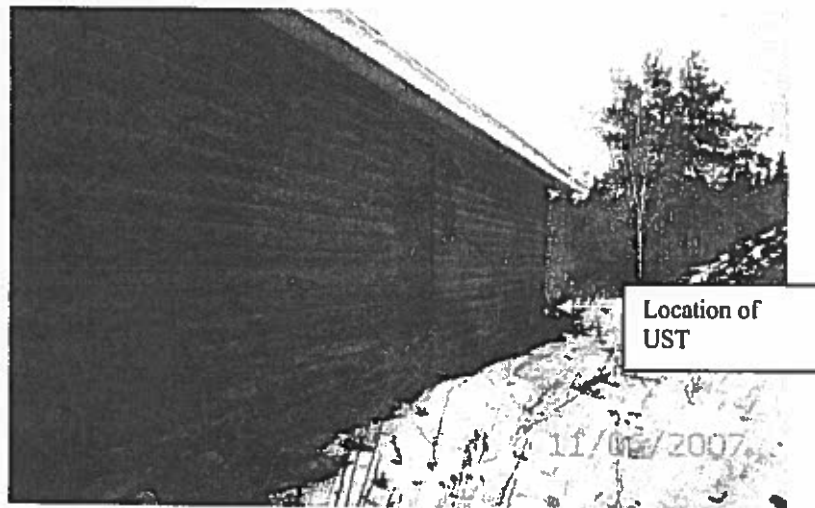
**Photo 9 same as above**
