Carcross Tagish First Nation Government

**SOURCE WATER PROTECTION PLAN
CARCROSS TAGISH FIRST NATION COMMUNITY WELLS
TAGISH, YT**

W23101256

March 2010

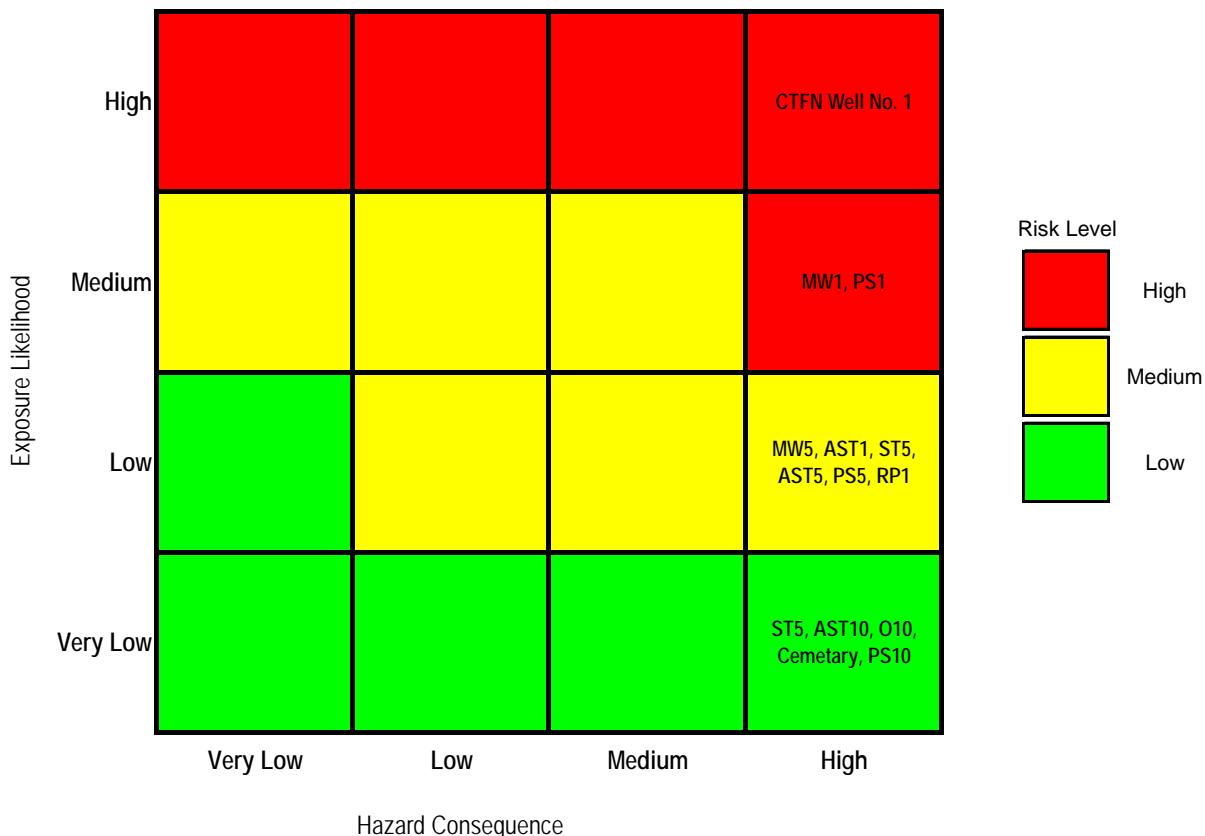
Figure 3: Risk Matrix

The risk matrix (Figure 3) provides the potential risk posed by each hazard located within the well capture zones for the CTFN Community Wells. The overall risk of “low”, “medium”, or “high” is assigned to each potential hazard identified within the capture zones and is based on the combined exposure likelihood and hazard consequence for each potential contaminant source.

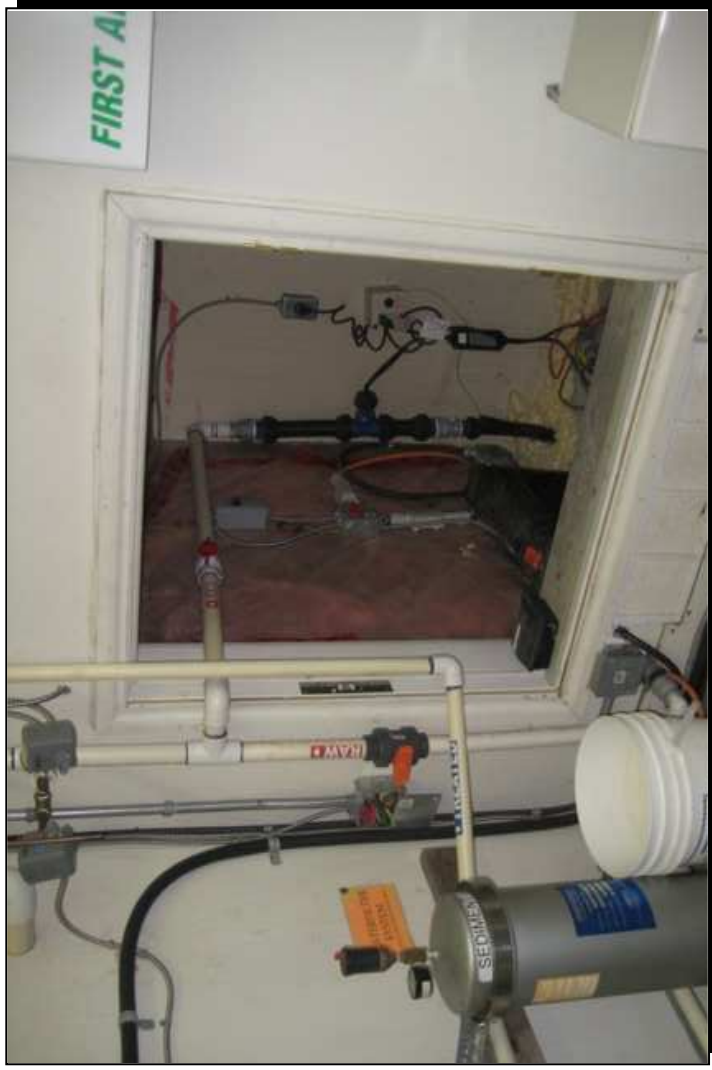
Photograph 3

View of the unused CTFN Community Well No. 1.

- Properly decommission Well No. 1 to eliminate potential conduit for short circuiting of contamination to the subsurface;
- Endorse and promote hazardous waste minimization and collection programs;

| TABLE 8: RISK REDUCTION/ ELIMINATION STRATEGIES TO BE CONSIDERED | | | | |
|--|--|---|--|---|
| CTFN Well No. 1 | Existing CTFN Well No. 1 | High | Ensure well head is not accessible and/or available for tampering | Decommission Well (recommended since no longer use) |

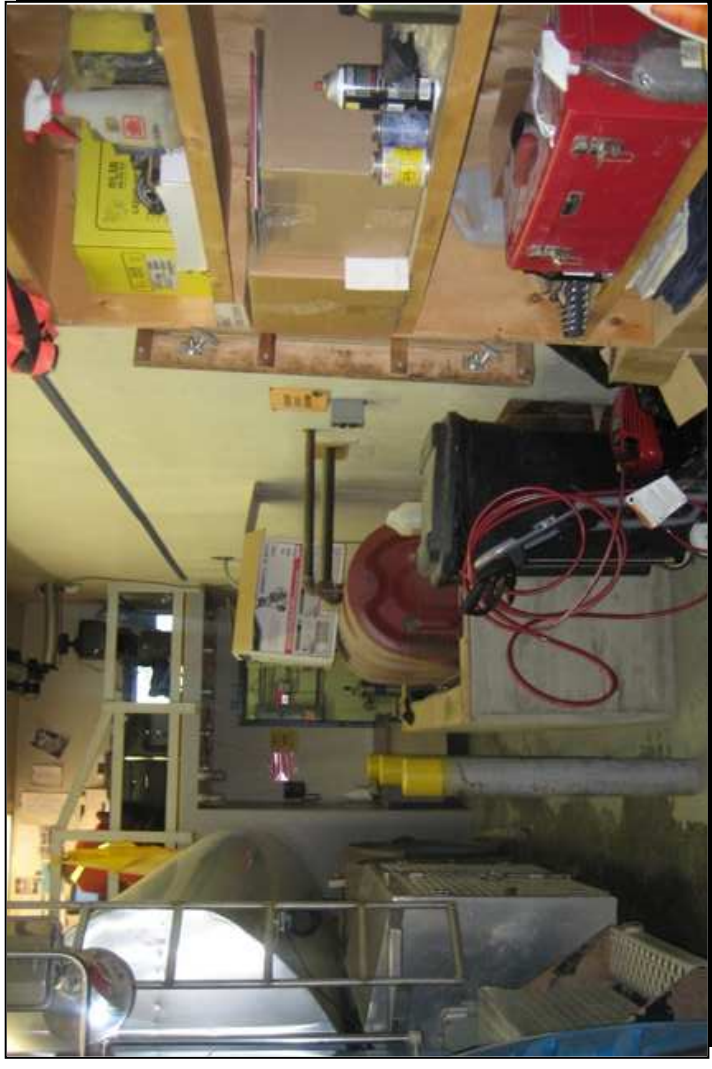
Photograph 4

View of the above-ground fuel storage tank inside the CTFN water truck garage building, looking west.

| TABLE 8: RISK REDUCTION/ ELIMINATION STRATEGIES TO BE CONSIDERED | | | | |
|--|--|---|--|---|
| AST5, AST10 | Above ground storage tank within the 1, 5 and 10 year travel time zones | Medium to Low | Secondary Containment. Flex Hose. Implement spill contingency plan. Ensure that fuel delivery personnel exercise extreme caution when refilling of ASTs. A CTFN representative should act as a spotter during filling of all ASTs. | Replace with propane systems. |

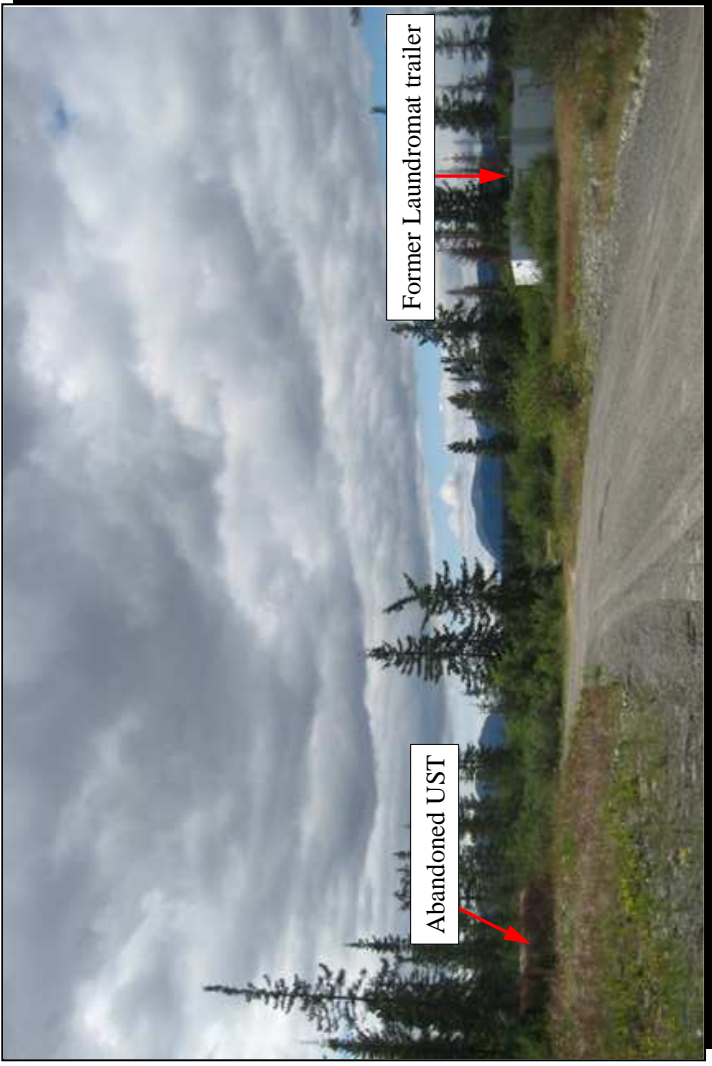
Photograph 5

View of the abandoned underground fuel storage tank for the former Laundromat trailer, looking west.

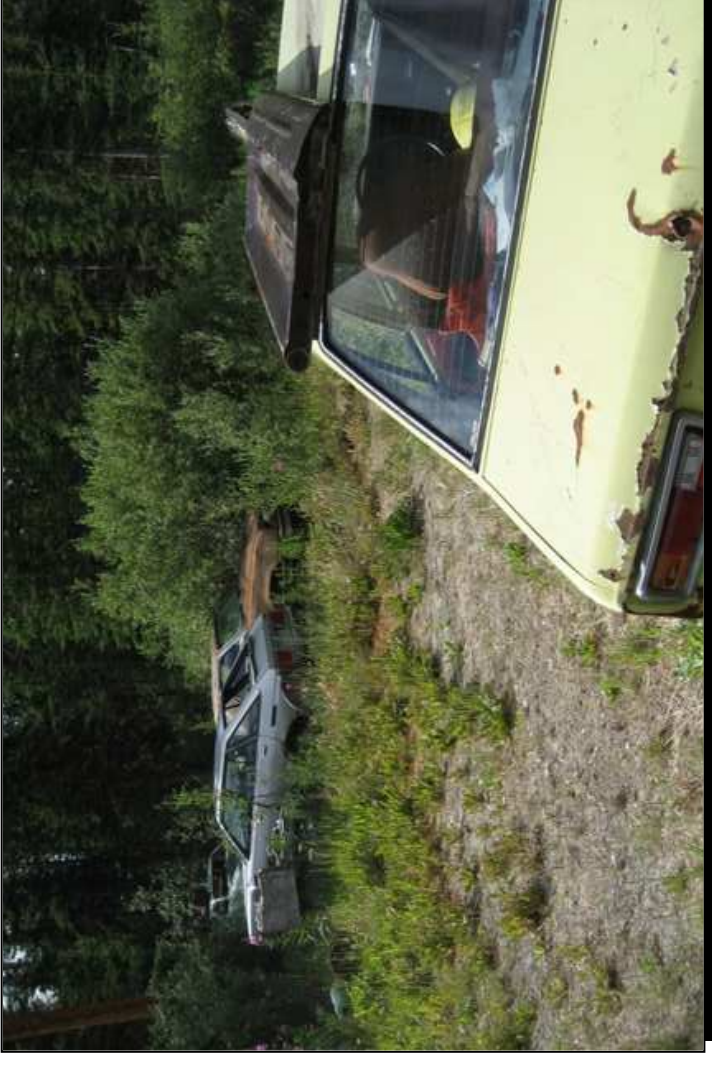
View of miscellaneous household wastes, including old car parts, scattered over the CTFN Tagish Community.

| TABLE 8: RISK REDUCTION/ ELIMINATION STRATEGIES TO BE CONSIDERED | | | | |
|--|--|---|--|---|
| HW1, HW5 | Household waste within the 1 and 5 year travel time zones | High to Medium | Monitor car hulks, old barrels and battery storage for leaks or spills. Implement spill contingency plan. | Remove current wastes and do not allow wastes to build up in WSPP zones (recommended) |

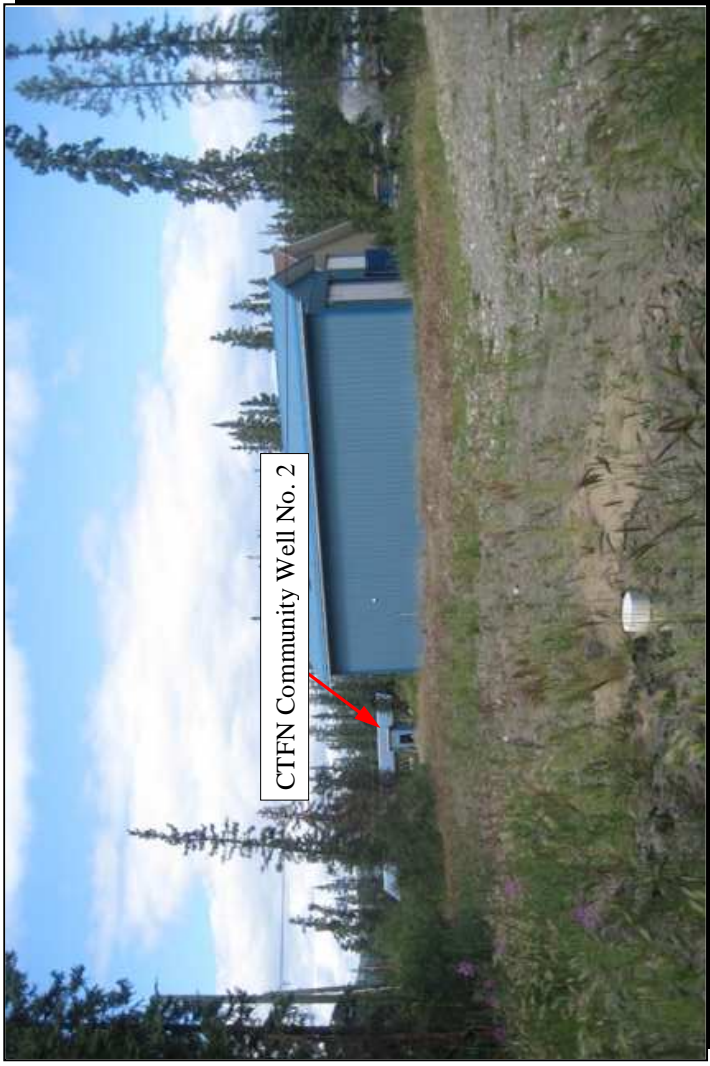
Photograph 7

View of the service pipe for the sewage system for the water truck garage building. CTFN Community Well No. 2 in background.

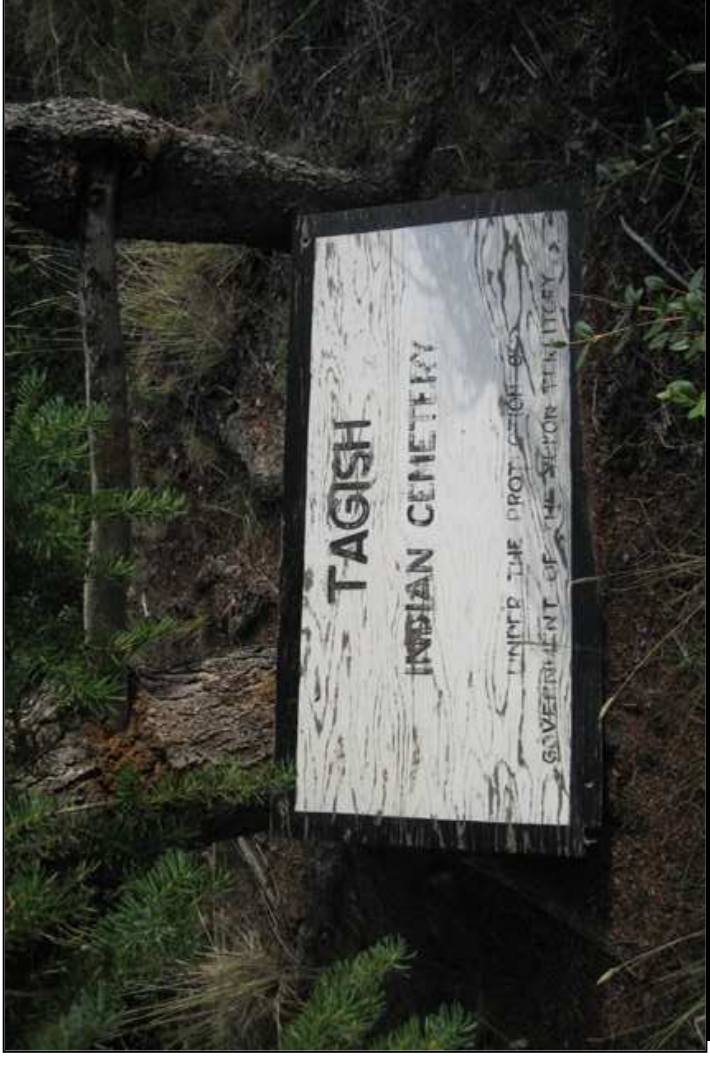
First Nation cemetery site located approximately 120 m southwest of the water truck garage building.
