Carcross Tagish First Nation Government

**SOURCE WATER PROTECTION PLAN
CARCROSS TAGISH FIRST NATION COMMUNITY WELLS
TAGISH, YT**

W23101256

March 2010

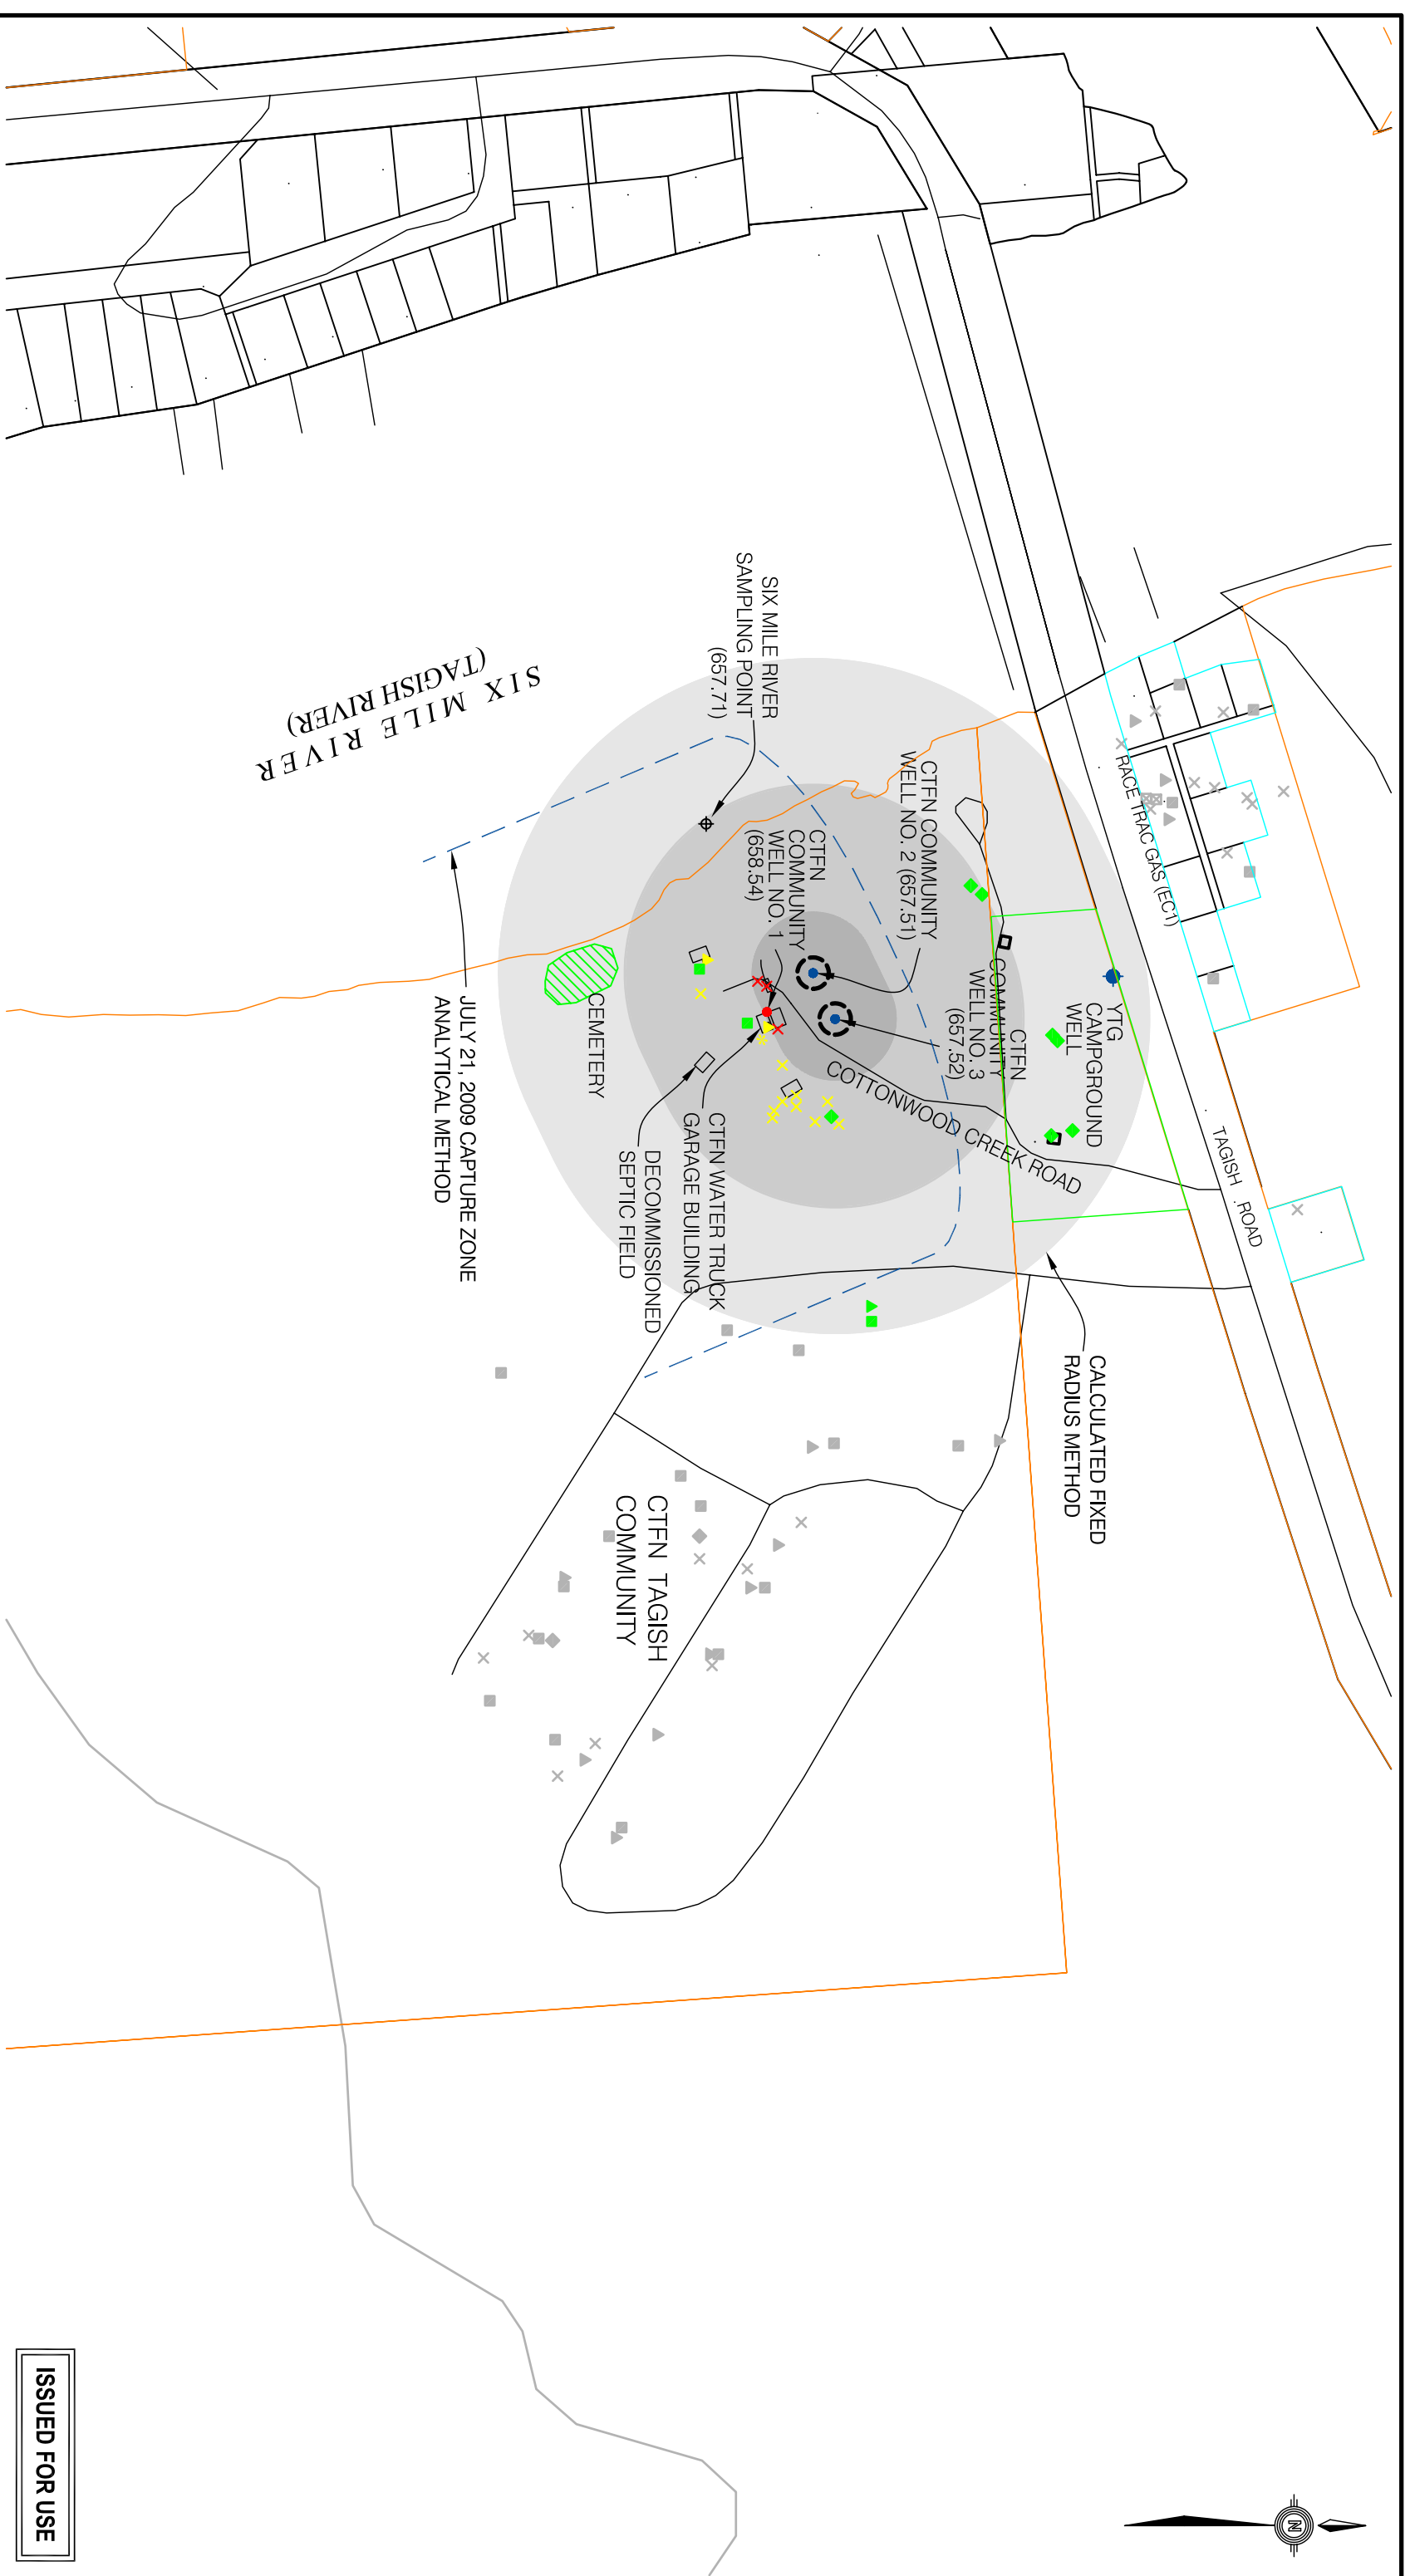
Because the Wells No. 2 and No. 3 are located in close proximity and the well capture zones overlap, both capture zones have been combined into one well capture zone as shown in Figure 2.

Marina as a result of gasoline leakage from a fuel storage tank. The quantity of gasoline leakage was unknown. The spill was identified as EC1 on Figure 2.

The resulting risk ranks “high”, “medium”, and “low” are then plotted on the Risk Map by using colors to represent different risk categories (Red=High, Yellow=Medium and Green=Low) (Figure 2).

Understanding, tracking, and managing identified risks become simple and intuitive through the use of a risk maps. Figure 2 shows the estimated travel times associated with the Community Wells (1 year, 5 year and 10 year travel time zones). Risk scenarios were plotted

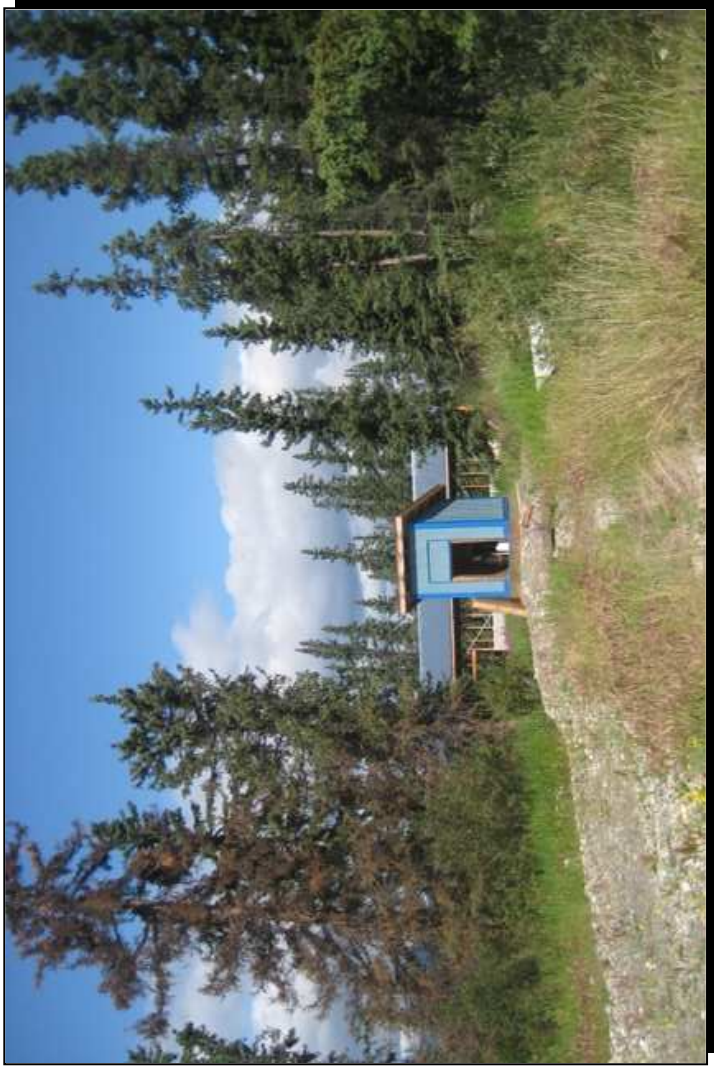
Photograph 1

View of CTFN Community Well No. 2 in pump house, looking north.

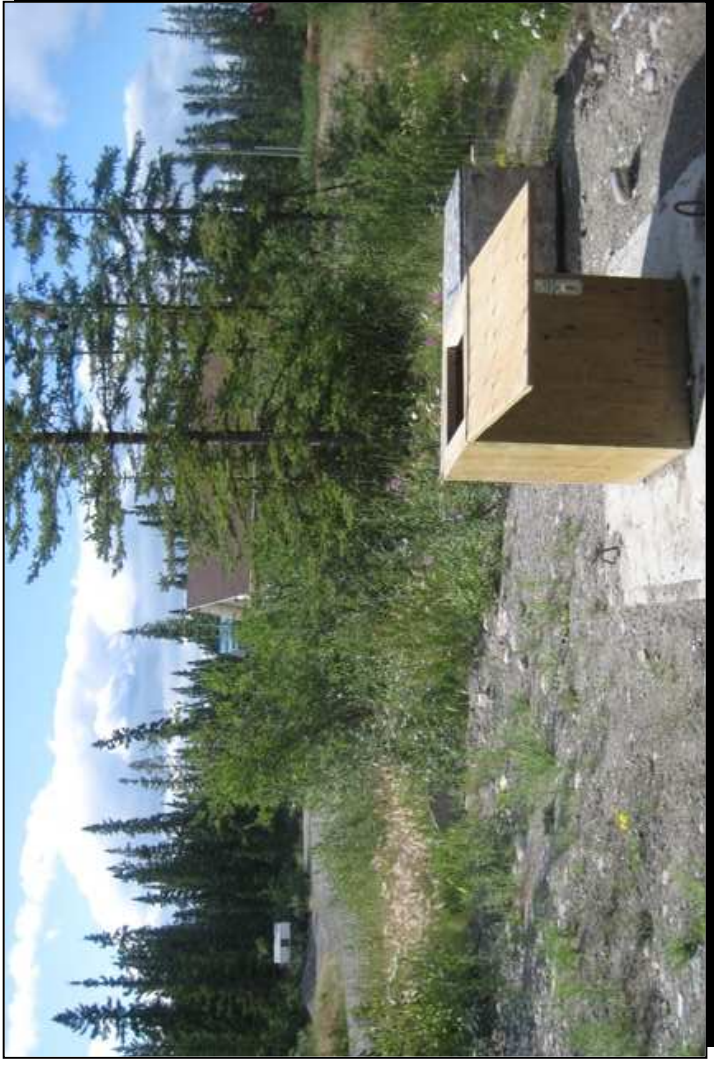
Photograph 2

- Well No. 3 is a 203 mm (8") diameter 51.2 m deep well (below grade), located in a wooden box approximately 55 m northwest of the water truck garage (see Photograph 2). This well was drilled and completed in August/September 2004 by Cathway Water Resources of Whitehorse as a supplementary source of water supply for the water system. Well No. 3 was completed with a 1.2 m long, 0.508 mm (0.020") slot size screen set between 49.7 m and 51.2 m-bgs.

View of CTFN Community Well No. 3 in a wooden enclosure, looking south. Water truck garage building and the condemned building in background.
