Appendix J Mayo Conceptual Flood Mitigation Design Options

Yukon Territory Flood Mitigation Conceptual Design Options
Appendix J Mayo Conceptual Flood Mitigation Design Options
 July 2023

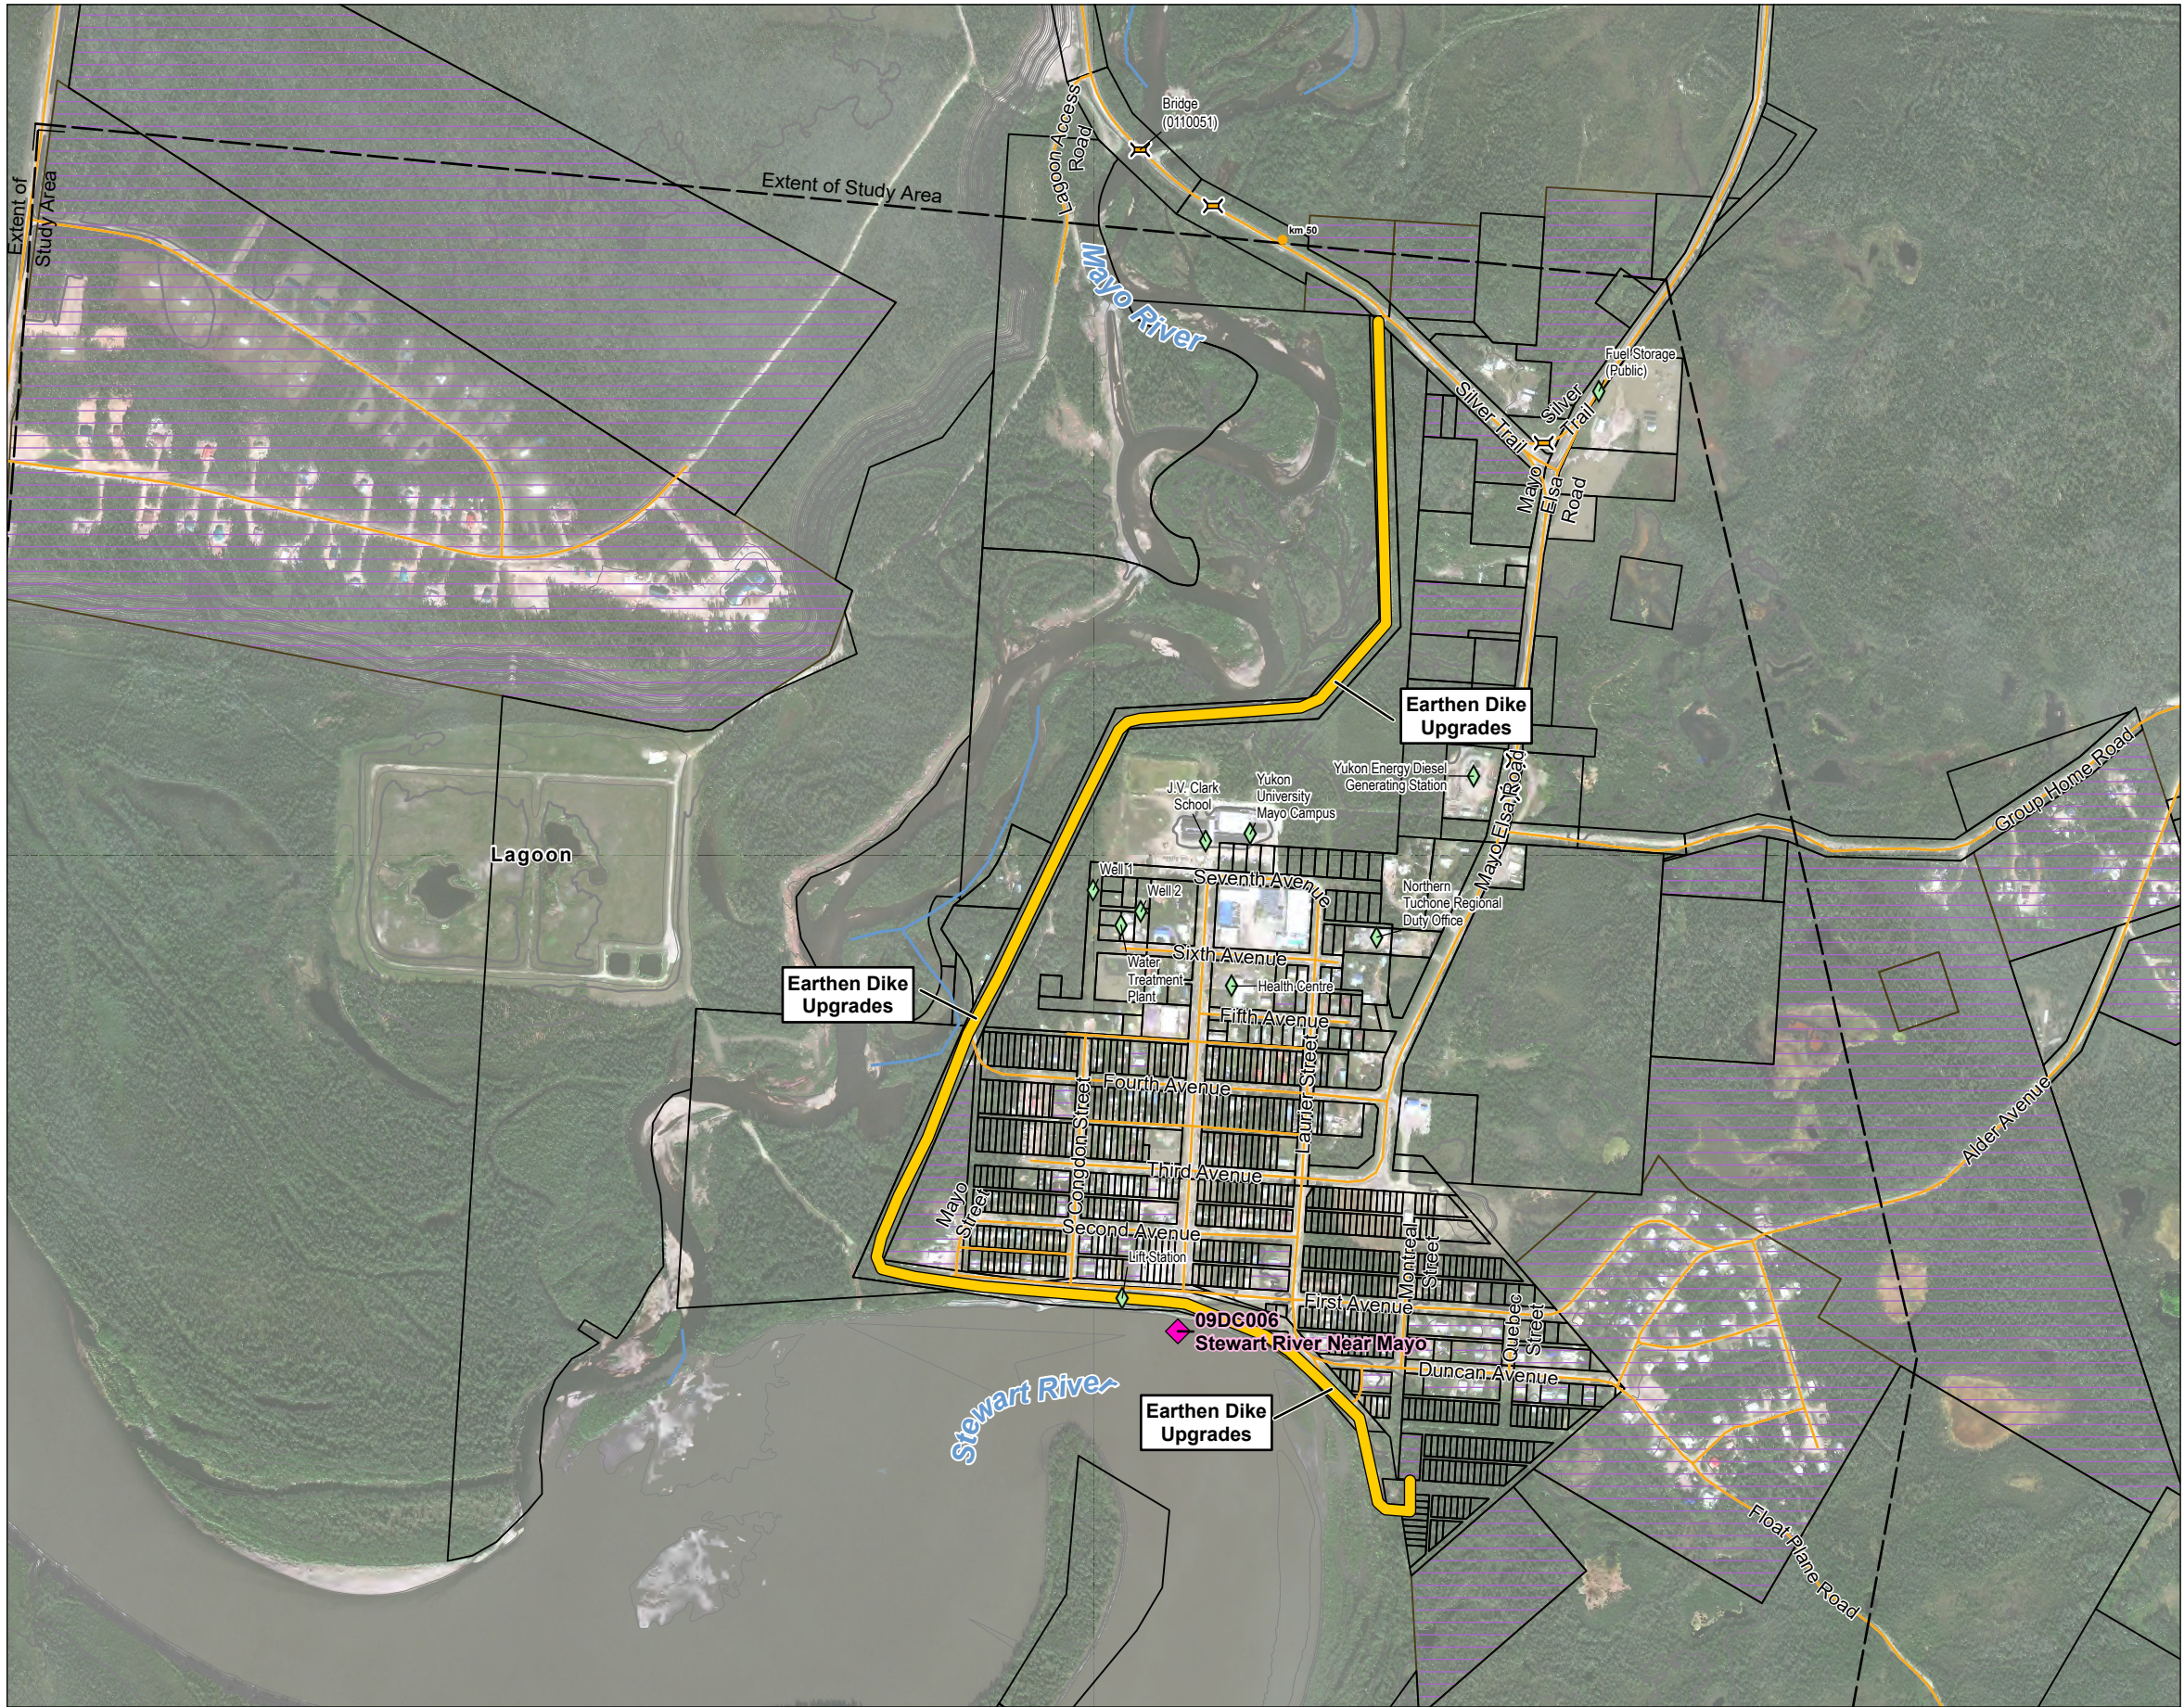
Figure No.
J3

Title
**Mayo Conceptual Flood Mitigation Design
- Option 1**

Temporary Sandbag Dike
